### LANDSLIDE MONITORING AND EARLY WARNING SYSTEMS IN AUSTRIA

Oslo, October 2016 rudolf.schmidt@die-wildbach.at margarete.woehrer-alge@die-wildbach.at

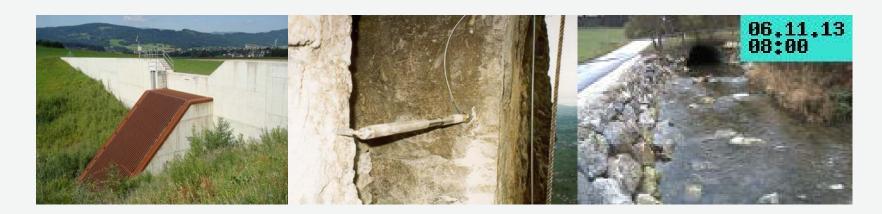
- complex monitoring architecture due to great variety of parameters
  - Landslides
  - Rockfalls
  - Hydrological parameters

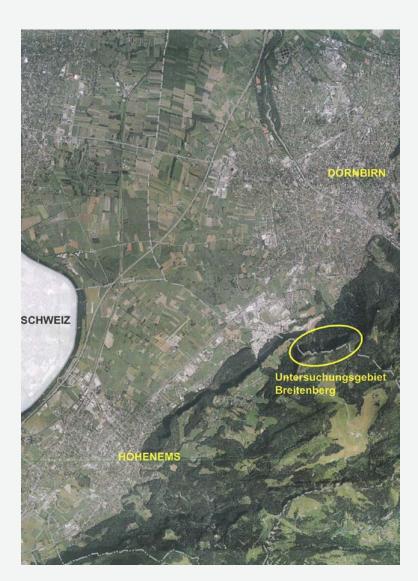
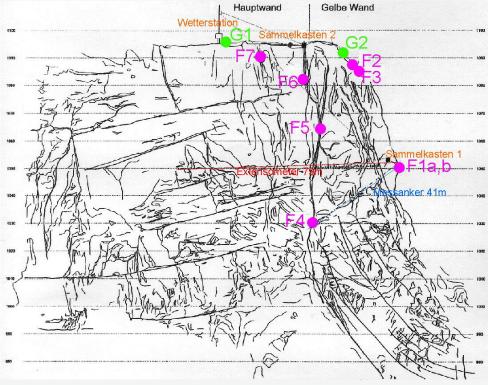
### **BREITENBERG**

Toppling of a rock pillar (180.000 m³) would cause base failure in the Rhine valley and subsequent destruction of houses.

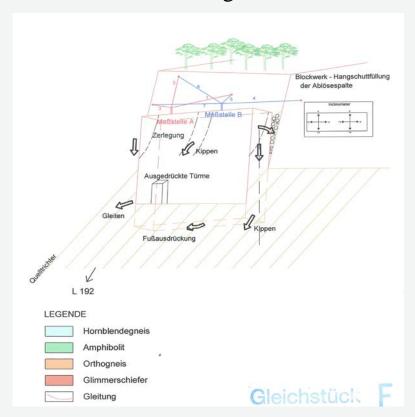
## **MÄSSTOBEL**

- Rock slide (800.000 m<sup>3</sup>)
- Debris jam in the Suggadin torrent
- Dam failure with floodwave endangers the settlement area of St. Gallenkirch and access road to Gargellen

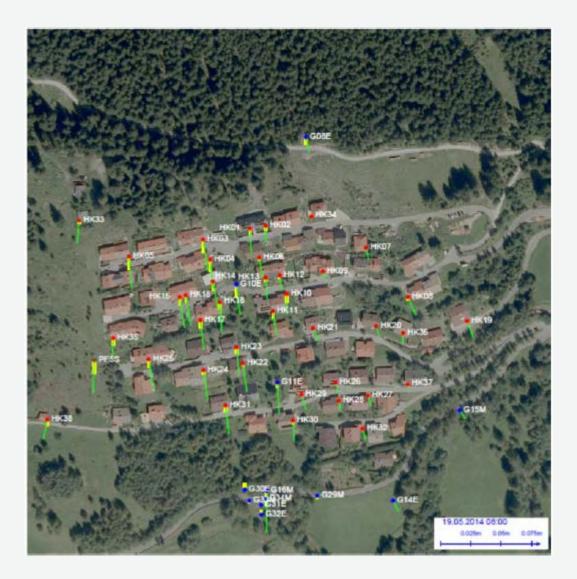
- control of water pipes
- Gauges
- Site control
- Surface movement control
- Depth movement control
- Conservation of evidence

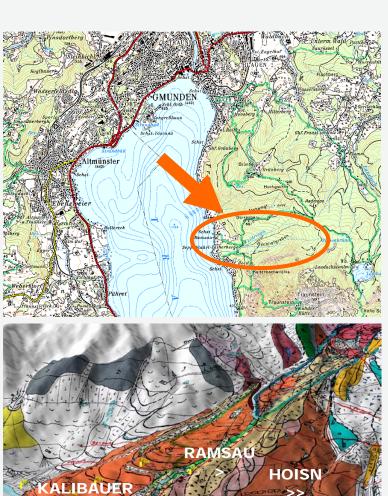
## **GSCHLIEFGRABEN**

Airbanna I acamananina
Remote sensing		Airborne Laserscanning
		Aerial Photographs
		Echo Sounding
Surface - surveying		Survey of drafts
		Observation of ranging-poles
		Monitoring of drafts
		Monitoring of anchors
		Webcam
		Terrestrial survey
		dGPS survey
Depth - surveying		Borehole logs
		Inclinometer
		Well gauges and piezometer
		TDR
		Seismic and geophysics
		Soil mechanics
Hydrology		Precipitation, temperature, barometric pressure
		Discharge in pipes and open channels

**TABLE 2:** Monitoring methods applied during the Gschliefgraben landslide remediation.

3,8 Million m³ of material involved in an earth flow presumably triggered by a rock fall in April 2006 Deposition height at the fan up to 8 m dislocation velocity up to 4,7 m per day 37 estates with 55 buildings were endangered 55 houses with 100 people were evacuated by a crisis committee

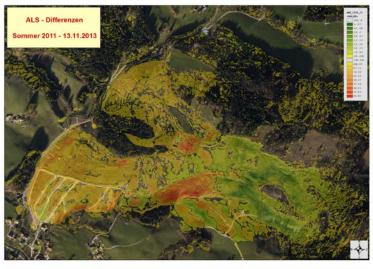
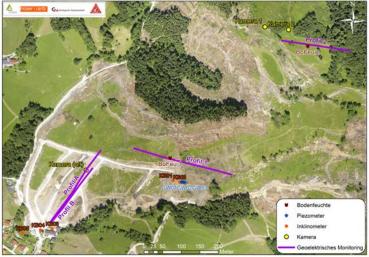
## **PECHGRABEN**

Remote sensing	ALS (Airborne Laserscan)
	UAV (unmanned aerial vehicle)
Surface surveying	of fissures
	direct measurement of movements
	photomonitoring (webcam)
	GPS-measurements
Depth surveying	borholes
	inclinometer
	well gauges and piezometer
	soil moisture
	geoelectrics
Meteorology	precipitation
	temperature

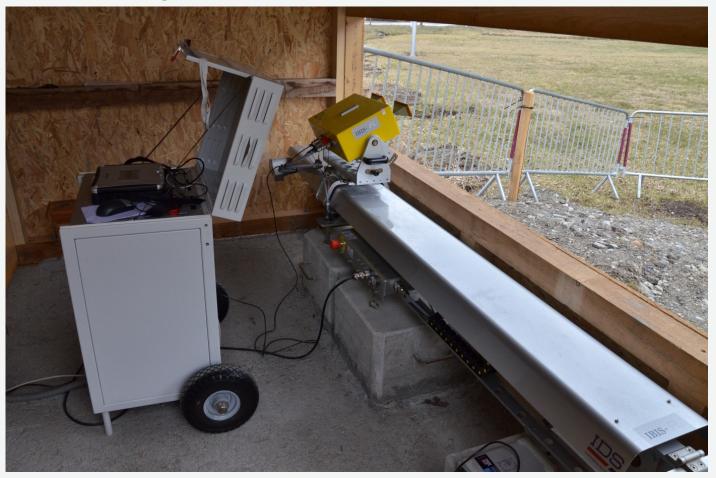
## IN-SAR – INTERFEROMETRIC SYNTHETIC APERTURE RADAR

- + Distance up to 4 km
- + whole area covered resolution below 1mm
- + Continous measuring (24/7) independent of weather
- Dense Vegetation and snow hinder accurate measuring
